# Steel Microstructure and Compressive Strength in Mortar When an Electrochemical Chloride Extraction is Applied

**Abstract:** The focus of this paper is to examine and review how applications of Electrochemical Chloride Extraction (ECE) affect the mortar mechanical properties. The mortar specimens were prepared with water/cement (w/c) ratio of 0.5 and contaminated with 5% of NaCl by mass of cement. A clean steel rod was centrally embedded in each specimen. The electrochemical treatments were based on different electrical current densities of 1, 3, 6 and 9 A/m<sup>2</sup> that were applied for 15 days. The state of corrosion was monitored before, during and after applying ECE regularly for two weeks. Selected samples from the cover zone of the untreated and treated specimens were taken to assess their chloride profiles. Despite being a slight change in the microstructure at the surface of the steel rod when this technique was applied (high current densities), the results of the compressive strength on mortars were not affected by ECE.

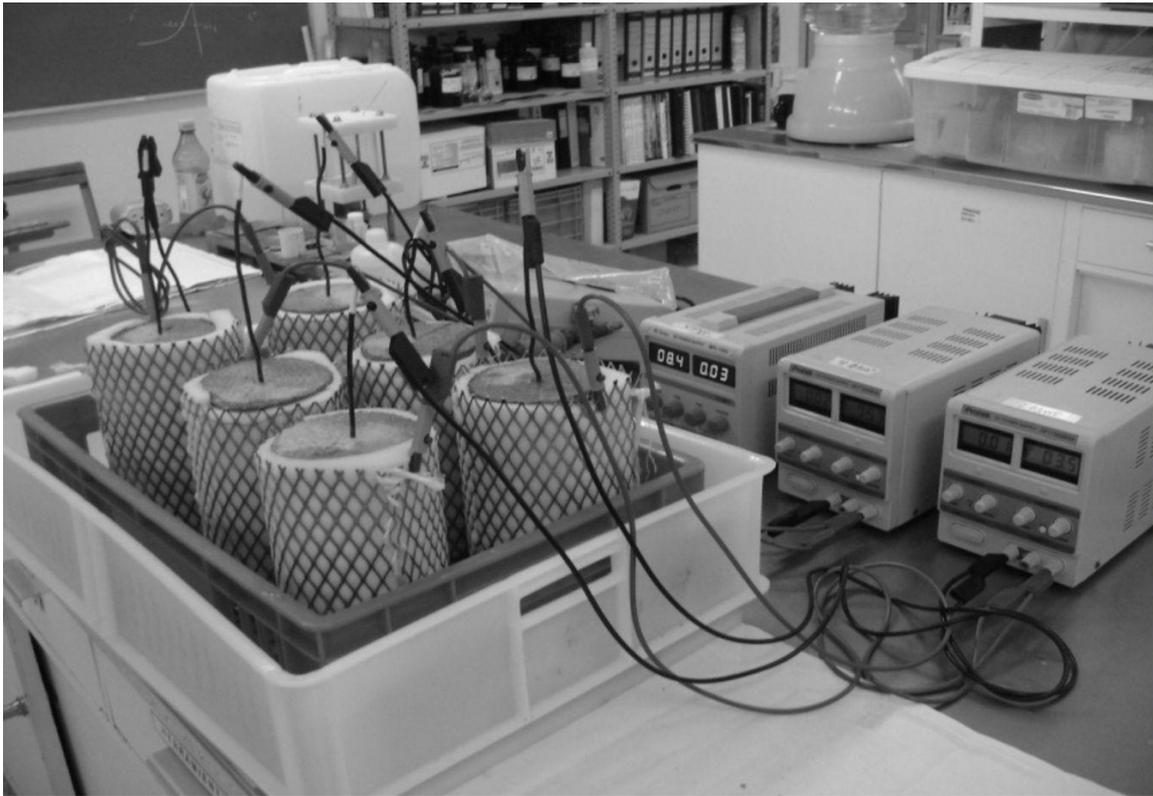
Figure 1: Mortar cylinders assembly used in the ECE

Seven specimens that were previously contaminated with chloride ions (Cl<sup>-</sup>), were covered with a soft piece of cloth that it was moistened in a saturated solution of calcium hydroxide (Ca (OH)<sub>2</sub>), and a steel mesh was placed on top of the soft piece of cloth. Each steel rod that was contained inside the mortar was connected to a negative terminal of a power supply, so that the steel reinforcement acted as a cathode; at the same time, the steel mesh was connected to the positive terminal of the power supply, which acted as the anode. The electrical current density delivered on the steel rod surface was 1, 3, 6 and 9 A/m<sup>2</sup>. The periods of this application of the extraction lasted 15 days.

In general, the methodology applied considered also an external cathode short-circuited with the rebar and located on the concrete surface opposite to the anode 17. After the treatment was finished, the electrochemical response of the rebars was periodically measured to valuate the effectiveness of the treatment and the ability of repassivation of the rebars. Figure 1 shows the image of the mortar cylinders assembly during the ECE. During the connection of the electric field the current density passed through the rebar was monitored with a data-logger.

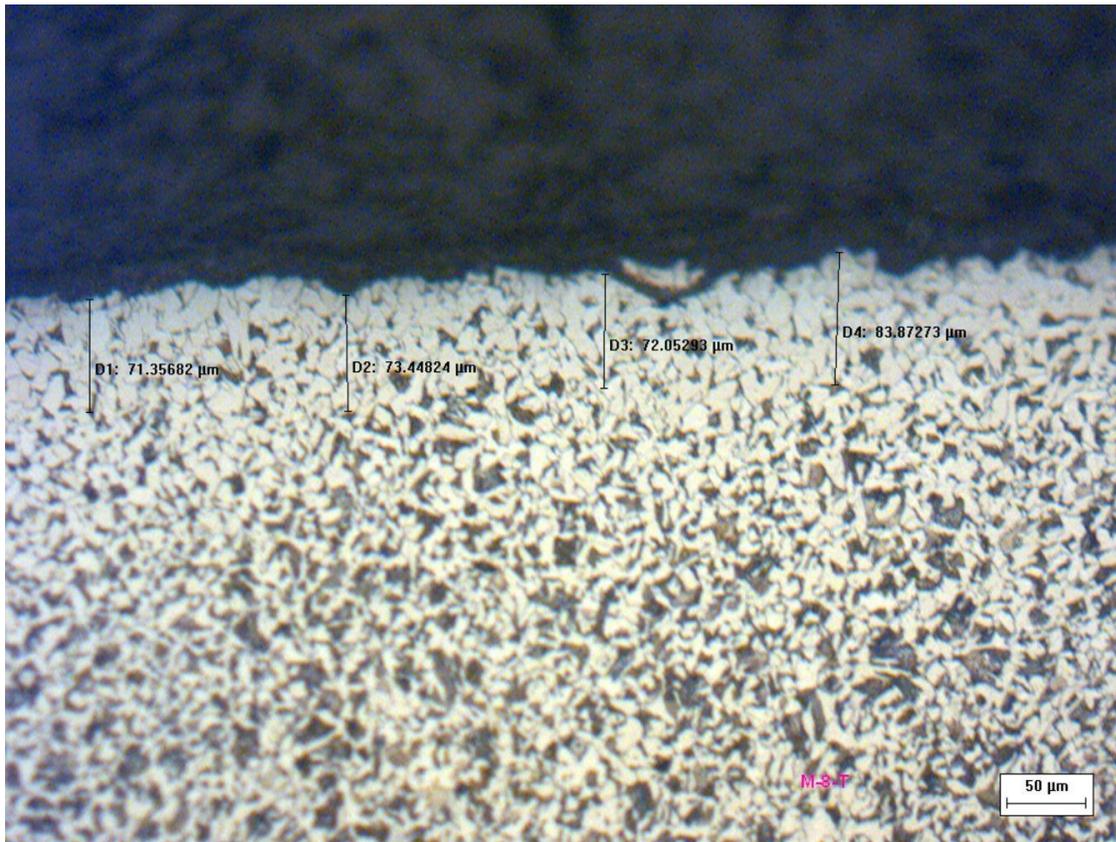
Figure 5: Microstructure of a steel rod contaminated with 5% of NaCl, with ECE at (6 A / m<sup>2</sup>)

According to Figure 5 and Figure 6, the rods were subjected to contamination of chlorides with a subsequent extraction, during 15 days of treatment by applying 6 and  $9 \text{ A/m}^2$  respectively. It can be observe an increase in the white zone (possibly a reduction in the amount of perlite), based on the increased current density, giving radial values from  $79 \mu\text{m}$  to  $104 \mu\text{m}$ .
