## Water Resource Management: Dam Collapse and its Implications on Agricultural production in Kankia, Northern Nigeria

Suleiman Iguda Ladan<sup>1</sup>

<sup>1</sup>Department of Basic and Applied Sciences Hassan Usman Katsina Polytechnic Katsina, Katsina State Nigeria

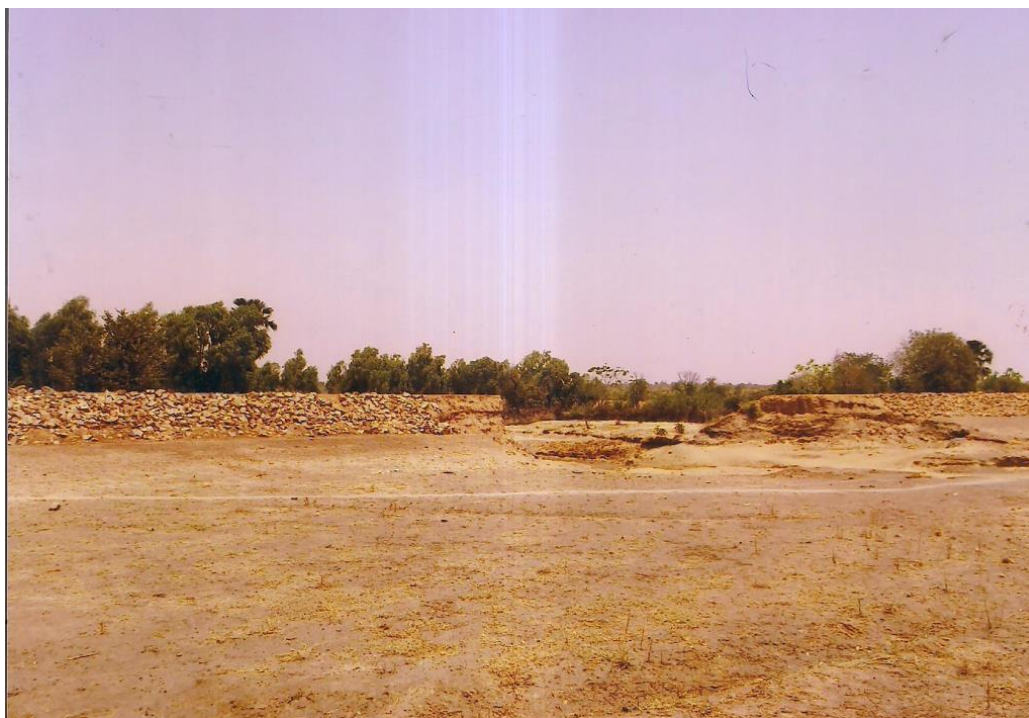
The Kankia dam collapsed on 2<sup>nd</sup> August 2013 when part of the dams embankment collapsed and according to the resident of the area it is the first

incident of collapse experienced since the construction of the dam in 1997. According to International Federation of Red Cross and Red Crescent Societies' Information Bulletin (2013), the seasonal heavy rains in August 2013 have resulted in a lot of rain water flowing into earth dams. This has resulted in over filling the dams leading to the collapse of earth dams like that of Kankia. There are

others that also collapsed in the neighbouring Kaduna State which include Kubau and Birnin Gwari earth dams (IFRCRCS, 2013). The heavy rains that filled the Kankia dam resulted in part of the dam's embankment collapsing and the water forced its way out of the dam into farmlands, gardens and open fields downstream. The collapsed dams' embankment can be seen on the figure 2 below

Figure 2: Section of the collapsed embankment of Kankia dam

A factor that is attributed to the collapse of most earth dams in Nigeria is lack of periodic maintenance as the dams need to be maintained to check its embankments and spillways. According to Chii (2010), earth dams need periodic inspection and monitoring against the development anomalous seepage paths either through the embankment, foundation or the abutment materials. However in the case of Kankia dam, the Caretaker Committee Chairman recalled that the dam was recently rehabilitated by the Federal Government of Nigeria under the constituency project of Member of Parliament representing the area, but still the dam collapsed (Ibrahim, 2013). The Chairman appealed to the representative to call the contractor back to site to reconstruct the embankment and widen the water spill way to avert future occurrence.

Field visit to the dam site for data collection was held in March 2014. In May 2014, the dam was rehabilitated by rebuilding the collapsed embankment and with the rainy season beginning in June, the water starts to recollect in the dam. However, once again after a heavy downpour of rain in the month of August 2014 the rehabilitated embankment collapsed again. The rain water that collects during the 2014 rainy season flows out of the dam. It is quite clear that the contractor that was awarded the contract for the rehabilitation of the dam did a shoddy job which leads to the collapse again this year.

The Kankia dam should be rehabilitated by rebuilding the collapsed embankment and this time a very credible contractor should be awarded the contract, so that the dam does not collapse again.

Once rehabilitated the dam should be periodically inspected and monitored so that the embankment and spillways are constantly checked particularly during the rainy season when large quantity of water collects in the dam.

There should be the employment of technical personnel that will be engaged in the supervision of the dam and its condition during the rainy season so that excess water is timely released out of the dam to avert any possible collapse in future.

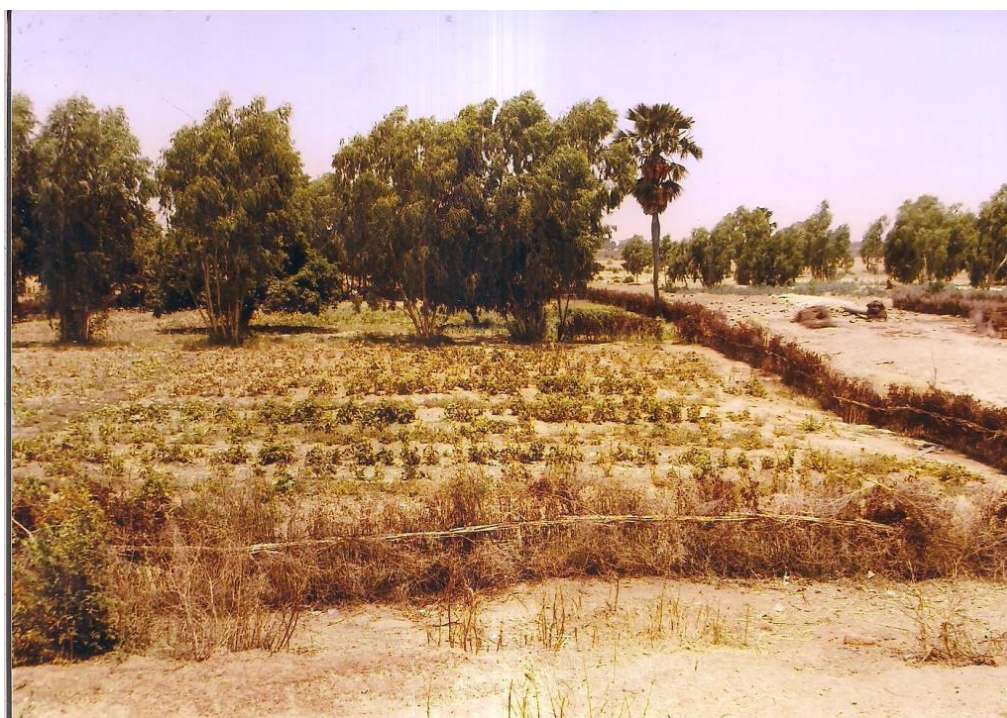
During field visit to the dam site it was clearly observed that plants that were planted in a garden behind the dam embankment were in serious physiological stress due to lack of adequate water supply (See Figure 3). This garden uses the water of a puddle behind the collapsed embankment as source of water supply. The growth of the onion, tomatoes, pepper and garden egg and beans that were planted in the garden have being drying and the growth of the crops have become stunted. It was also observed that lower animals such as goats and sheep were observed to be scavenging on the remnants of grasses that could still be found on the dam which is quite inadequate for the large number animals that were seen there.

Figure 3: Garden crops showing symptoms of physiological stress behind the dam embankment

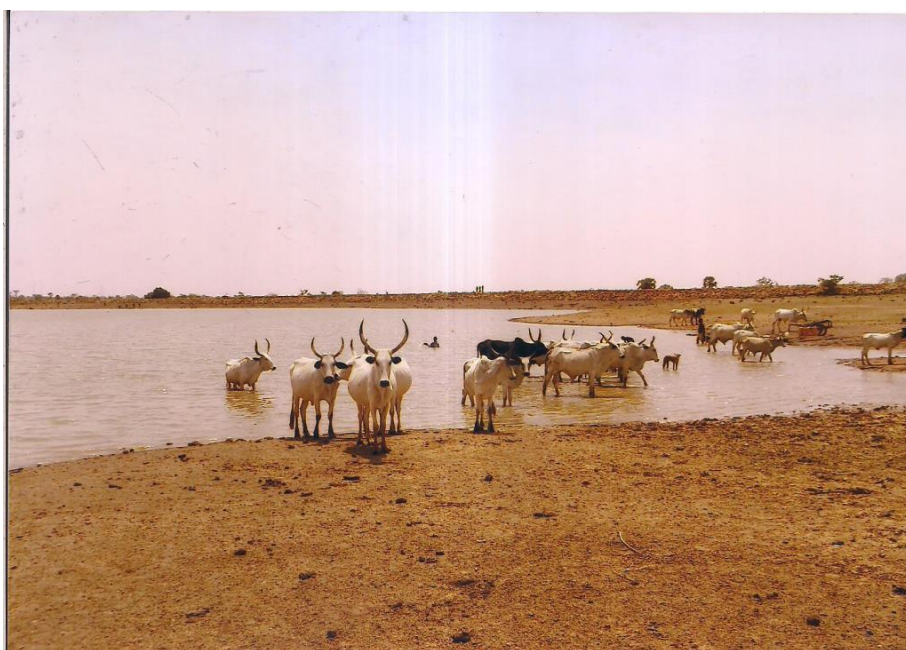
about eight kilometers away from Kankia. The Sagawa dam was also visited and the dam contain water with series of activities were seen to be taking place there. These activities include people using jerry cans to collect water, drawing of water to irrigate garden crops, fishing activity and herds of livestock entered the dam to drink water (see Plate No. 3). One of the irrigated gardens of onions and beans could be seen on Figure. 4. Irrigation farmers interviewed reveal that they have farmland at Kankia which they could not irrigate due to the collapsed dam. Therefore, they have to come to Sagawa and rent farmlands for dry season farming.

Figure 4: Sagawa dam with herds of cattle in it and a fisherman behind them.

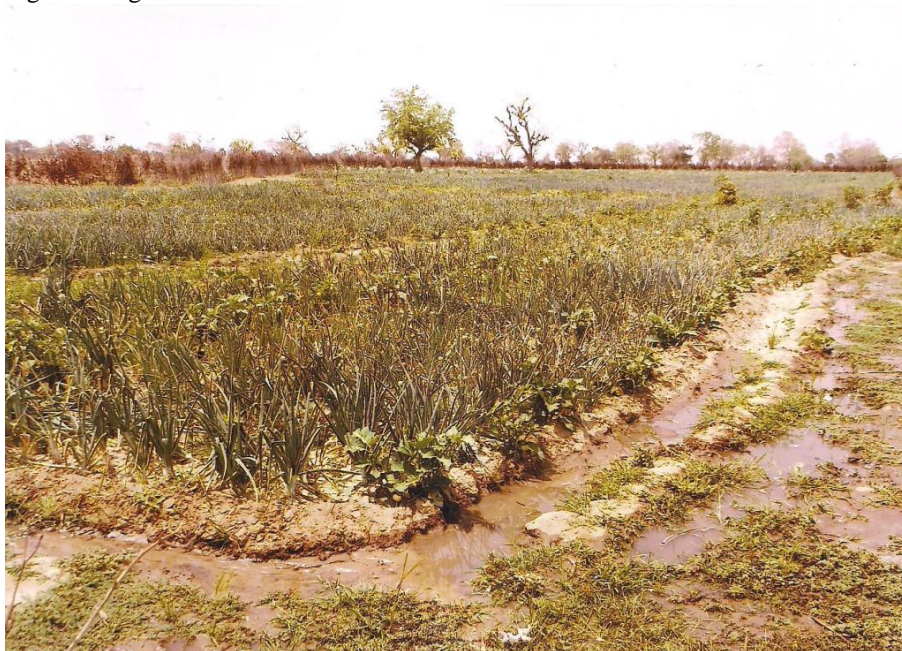
Figure 5: An irrigated garden of onion and beans close to Sagawa dam
